## Costa Concordia at Giglio Island (Italy): The Refloating of a Cruise Ship

*A review on world Historical Buildings and Great Civil Monuments  
strengthened by Sireg solutions*

## Costa Concordia: the Refloating of a Cruise Ship

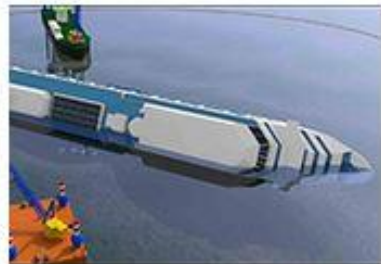
1. Vessel stabilization
2. Underwater support and portside sponsons
3. & 4. During parbuckling the vessel was positioned on the support systems. Then it was equipped with sponsons on the starboard side too.
5. Refloating stage

1. Holdback system and stabilization

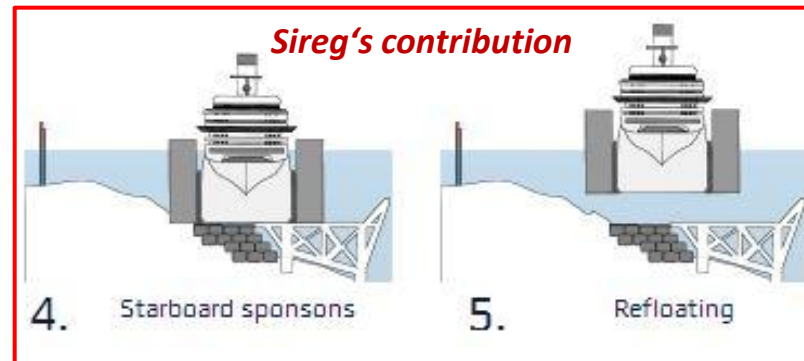
2. Underwater support and portside sponsons

3. The Parbuckling

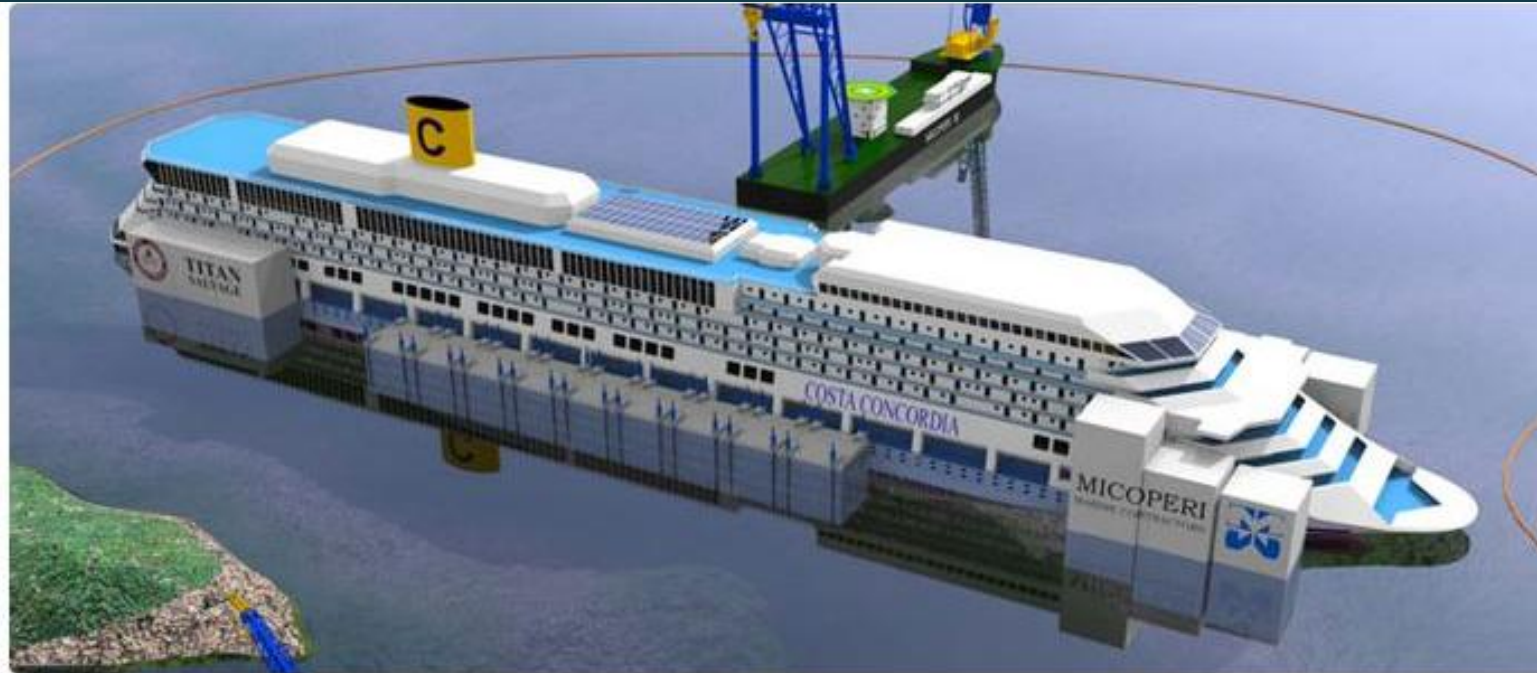
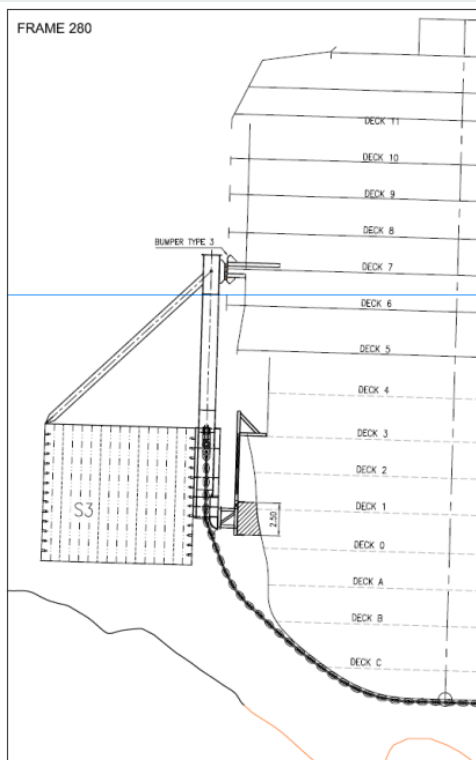
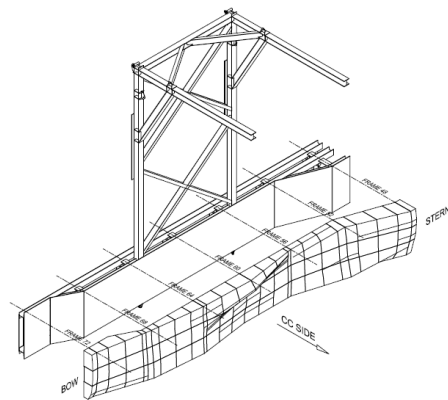
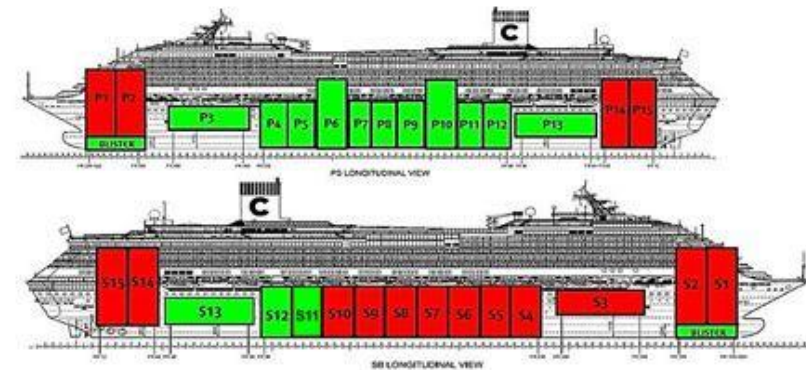
Scheme of the bumper and of the sponson for the refloating phase

Scheme of the bumper and of the bags injected with PU resin

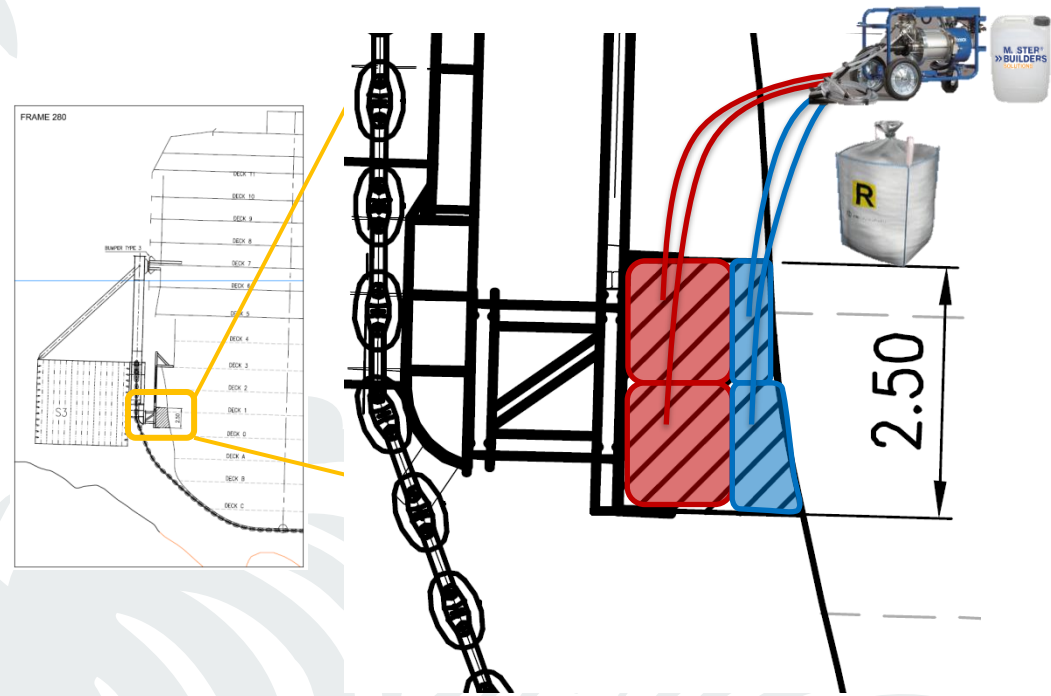
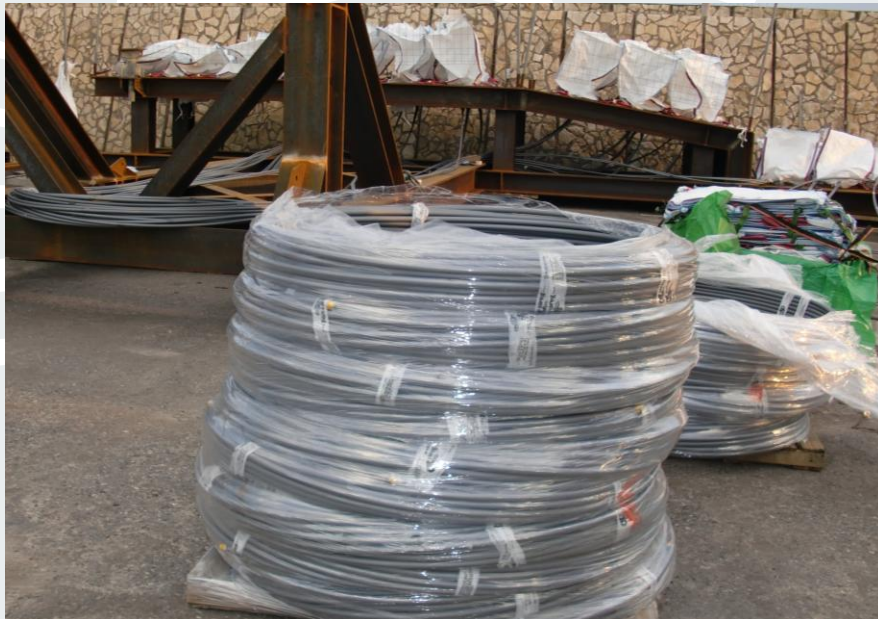
During project phases 3 and 4, Sireg Geotech was selected to supply its high-pressure TP pipes.

These **high-strength injection hoses** were installed on each sponson, on both sides of the vessel.

Two-component polyurethane resins were then injected through the pipes to create, inside each sponson, a series of artificial buoyancy bags.

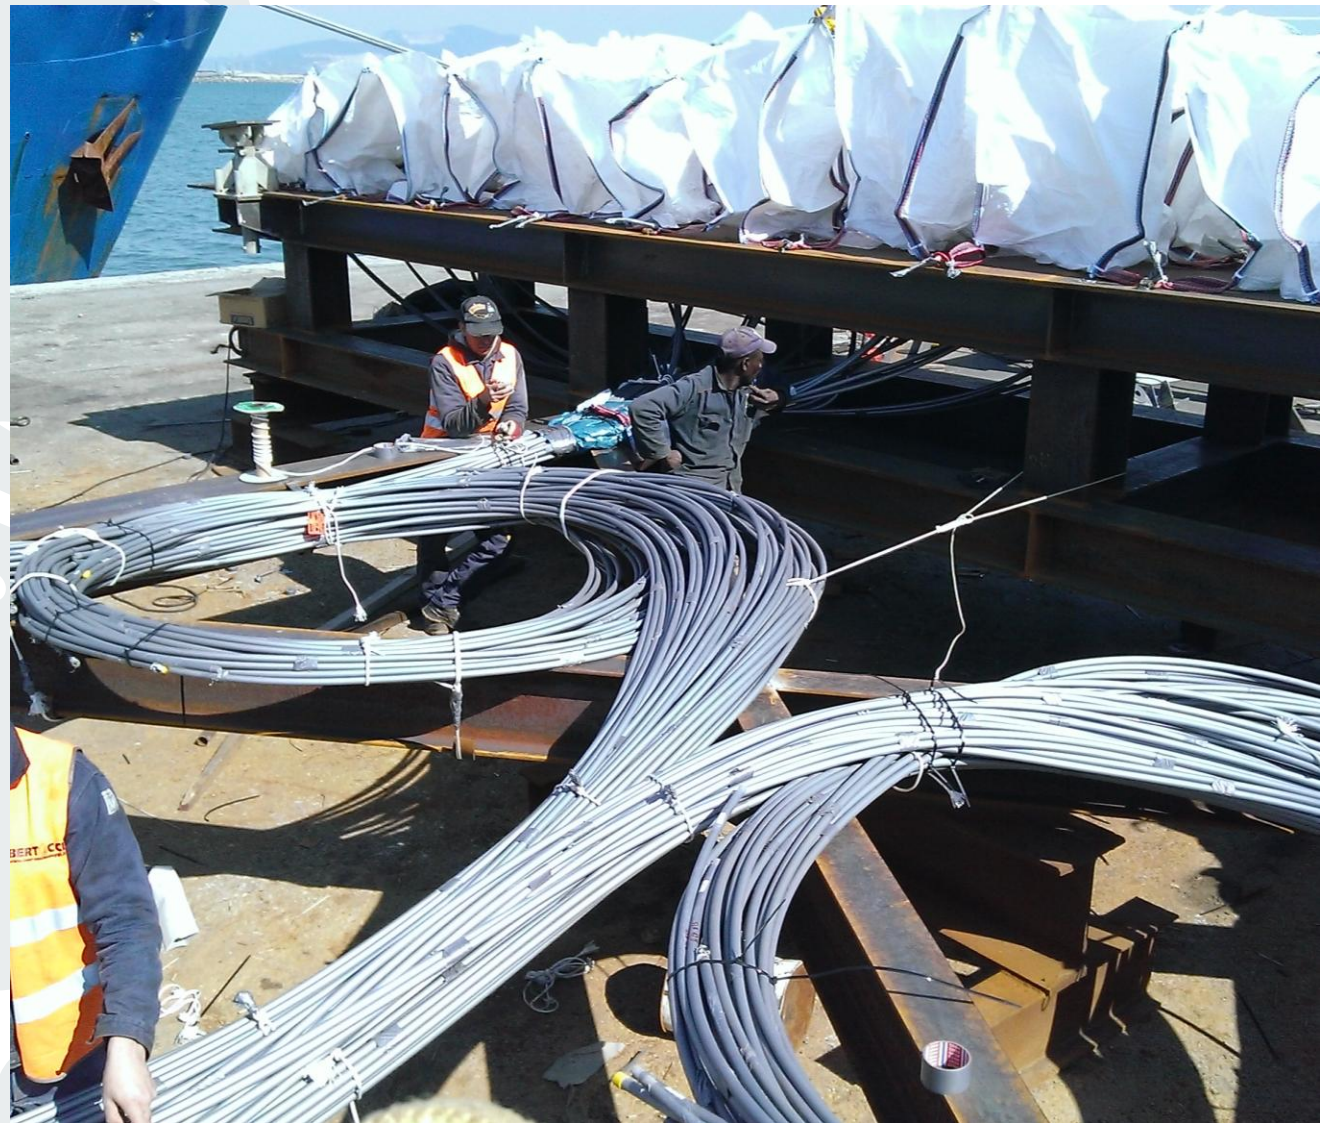
*Sireg Geotech high pressure pipes are installed to drive PU resins inside the bags*

- **High-capacity anchor installation and tensioning:** to stabilize the vessel and maintain its position during the refloating operations.
- **Large sponson-mounted bags on both sides of the ship:** providing additional buoyancy.
- **Refloating assisted by pumps and side bags:** with significant volumes of polyurethane resin injected to create artificial buoyancy, facilitating the ship's flotation and restoring its proper navigation attitude.
