# Historical Sireg

## Assisi Cathedral: Renovation After an Earthquake (Italy)

*A review on world Historical Buildings and Great Civil Monuments strengthened by Sireg solutions*

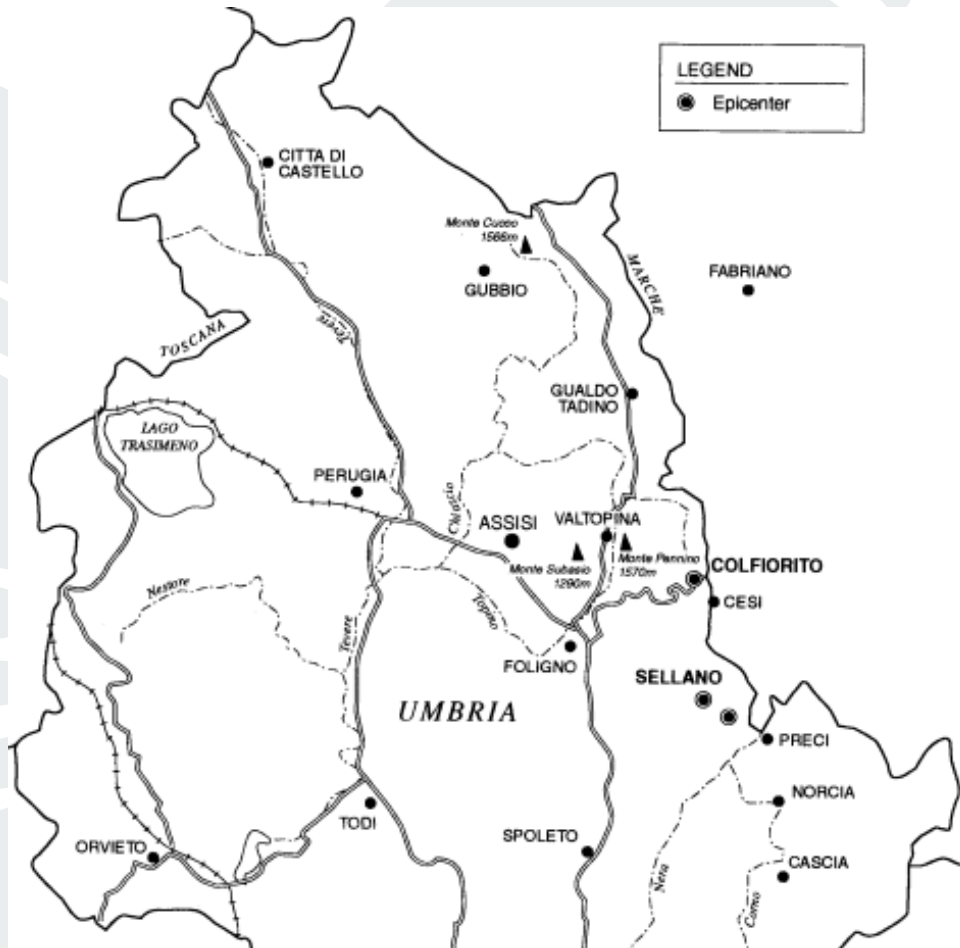
Earthquake epicenter (Colfiorito), a few km from Assisi

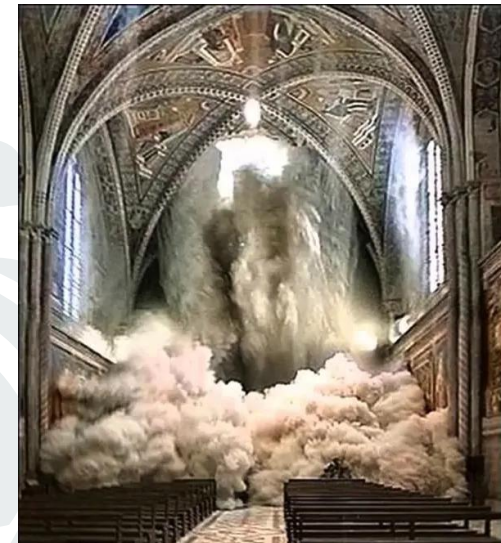
The earthquake of 26 September 1997 caused extensive damage to the Upper Basilica in Assisi, including the collapse of the vault at two points. Tragically, four people lost their lives; their memory is honored with an inscription on the floor at the basilica's entrance.

Significant damage also affected the south tympanum of the transept, where 130 square meters of medieval frescoes were shattered into fragments. The basilica remained closed to visitors for two years while restoration works were carried out.

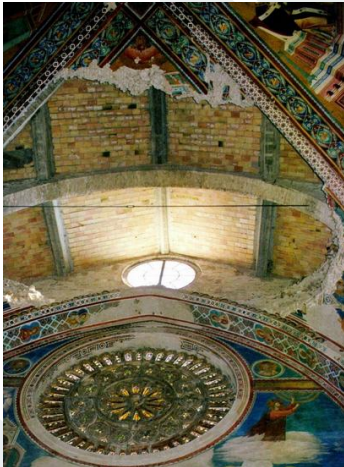
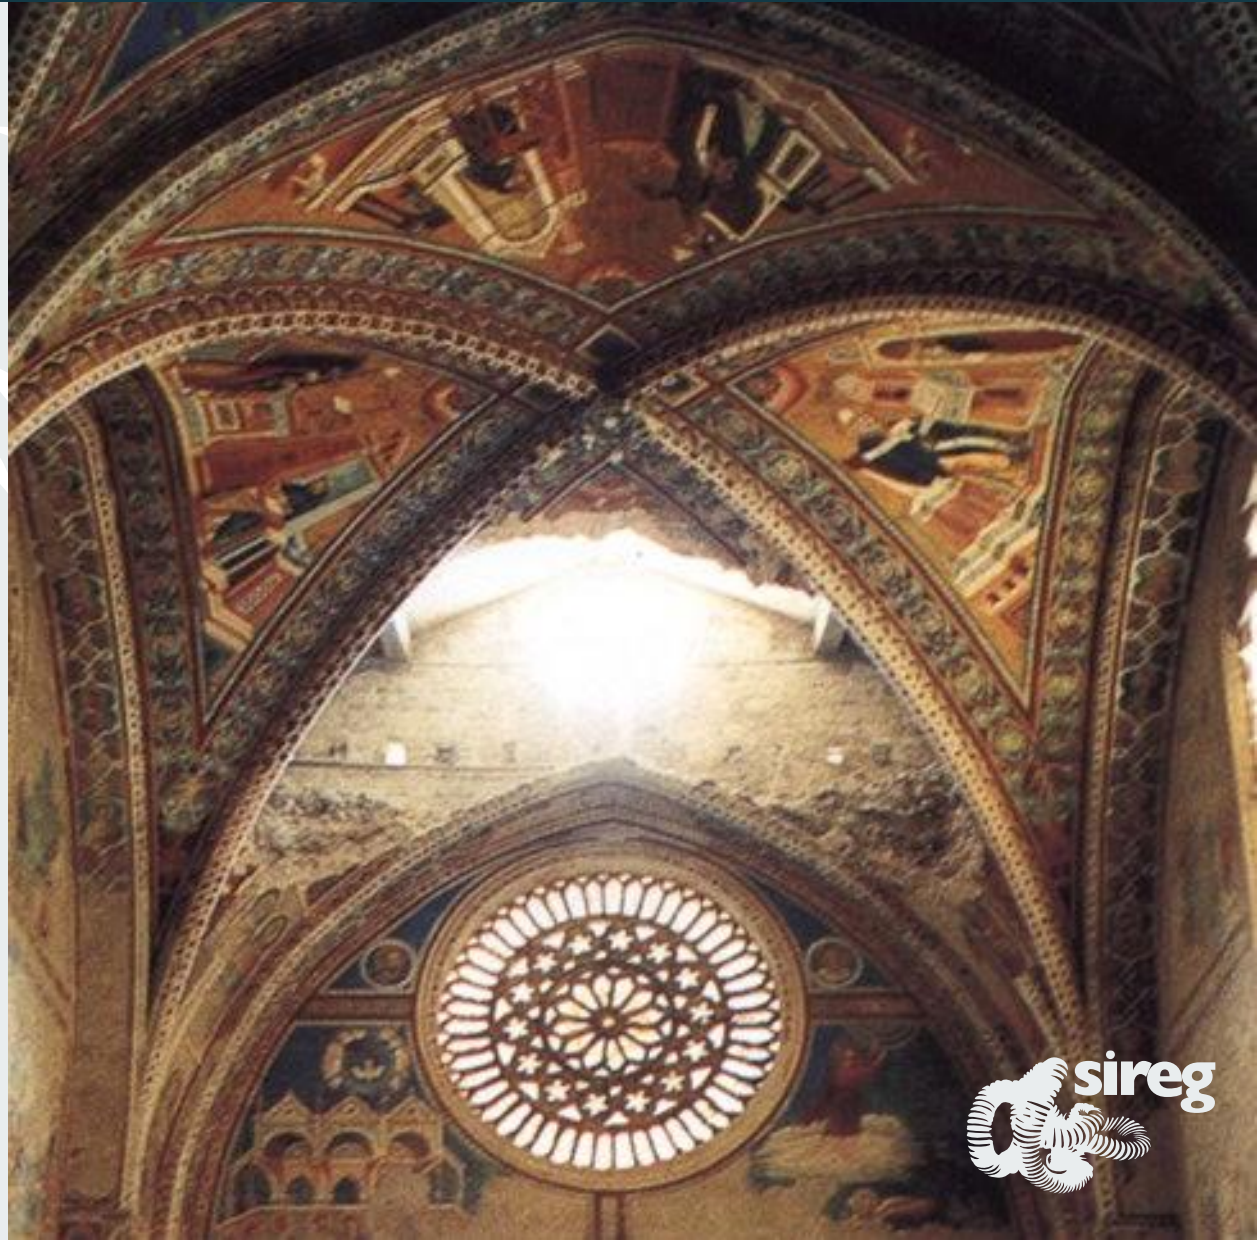
The earthquake caused the collapse of part of the frescoes on the vault of the first span:

- the San Girolamo (attributed to the young Giotto), where the Four Doctors of the Church were depicted;
- the figure of San Matteo, on the vault portraying the Four Evangelists by Cimabue.

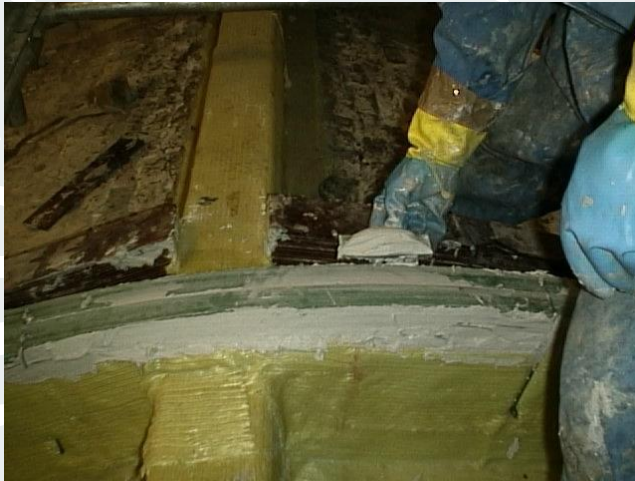
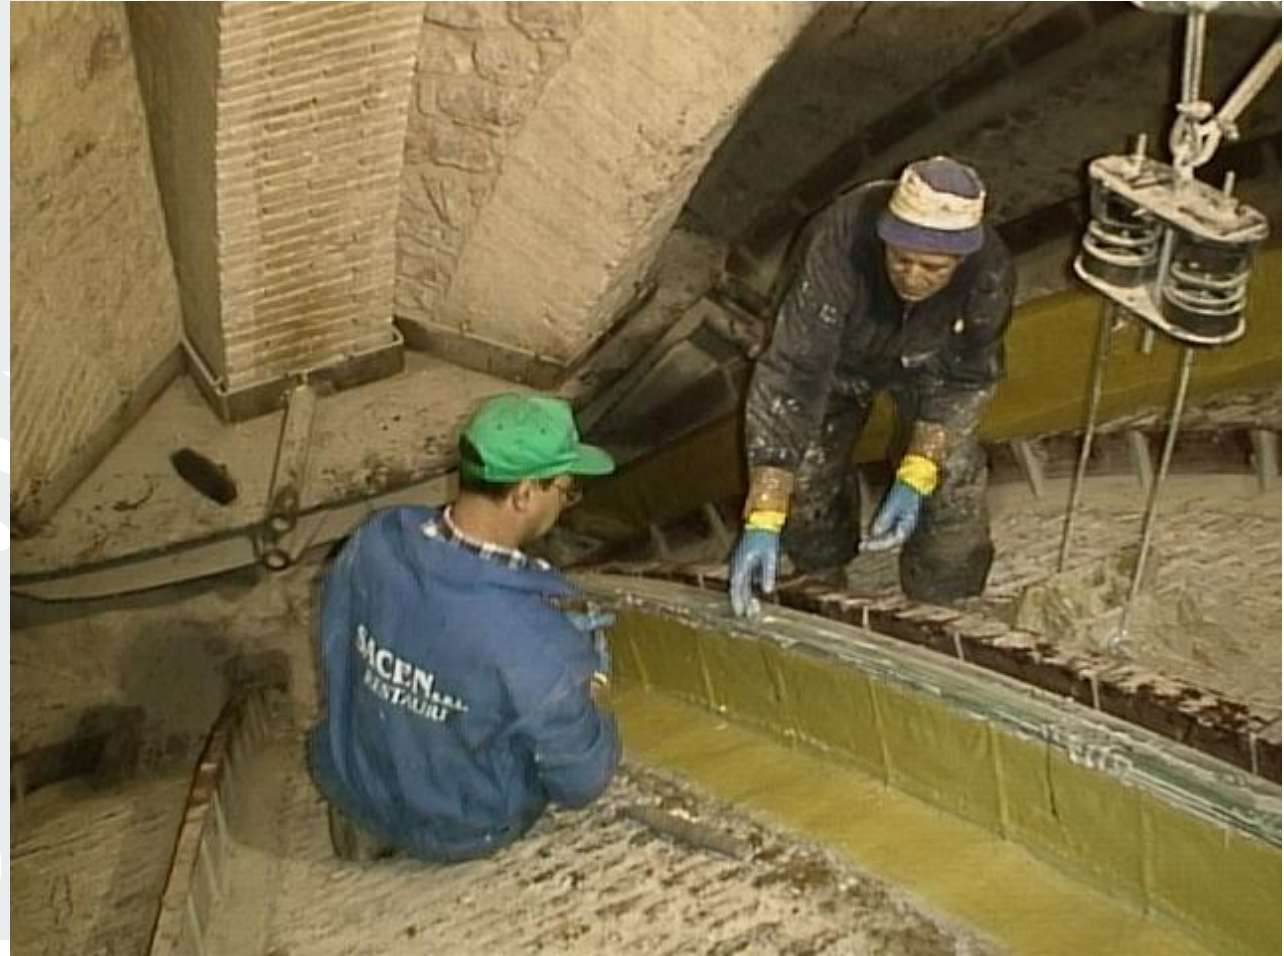
During the repair and strengthening works, which took place in the immediate aftermath, **Sireg** composite materials were extensively applied. **Carbopree®** and **Glasspree®** laminates and rebars, together with **Arapree®** bars and fabrics were approved by the engineering teams.

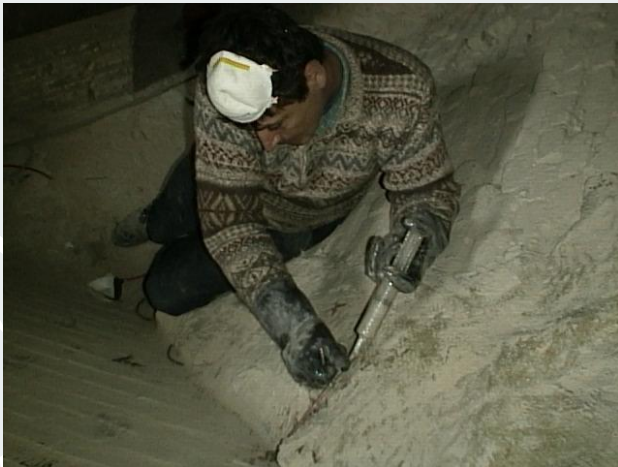
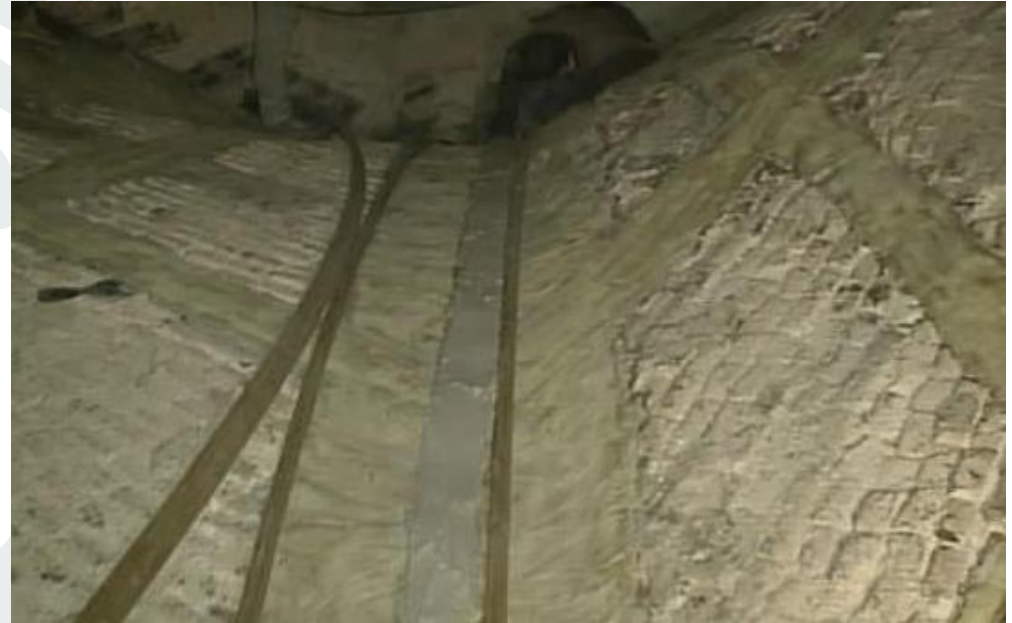
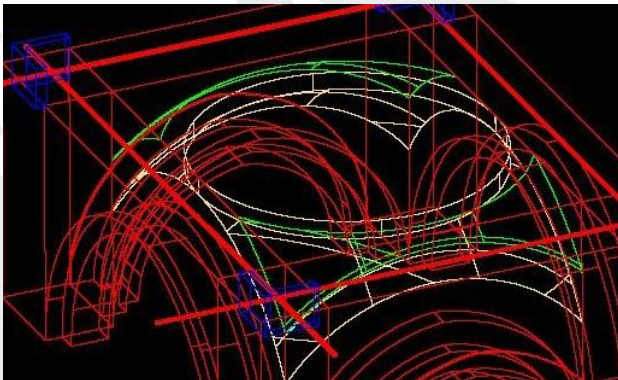
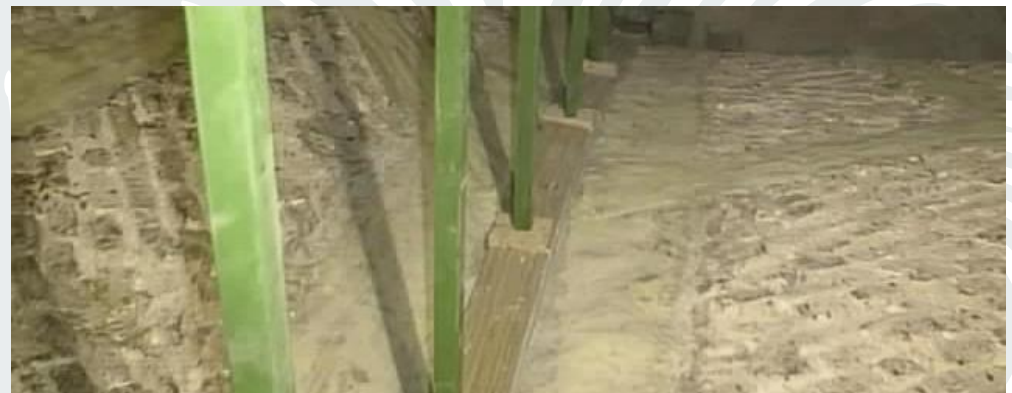
Among the intervention solutions chosen by the designers, **Arapree**<sup>®</sup> fabrics and flat bars 40 x 7 mm

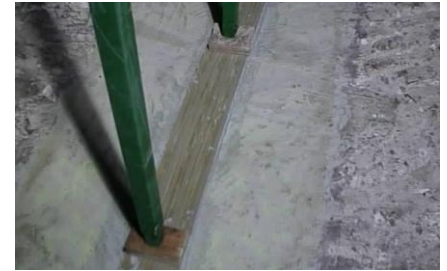
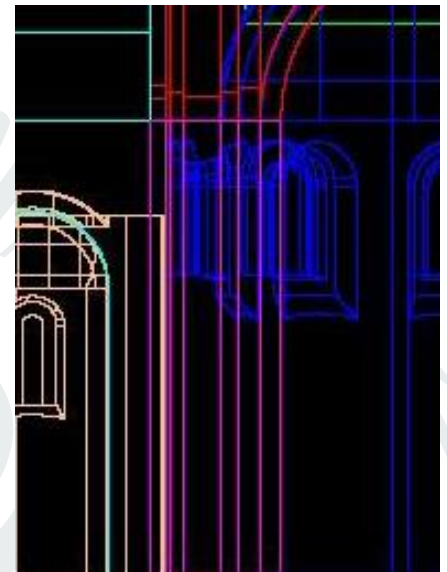
**Arapree®** and **Glassree®**  
solutions during the  
installation stage

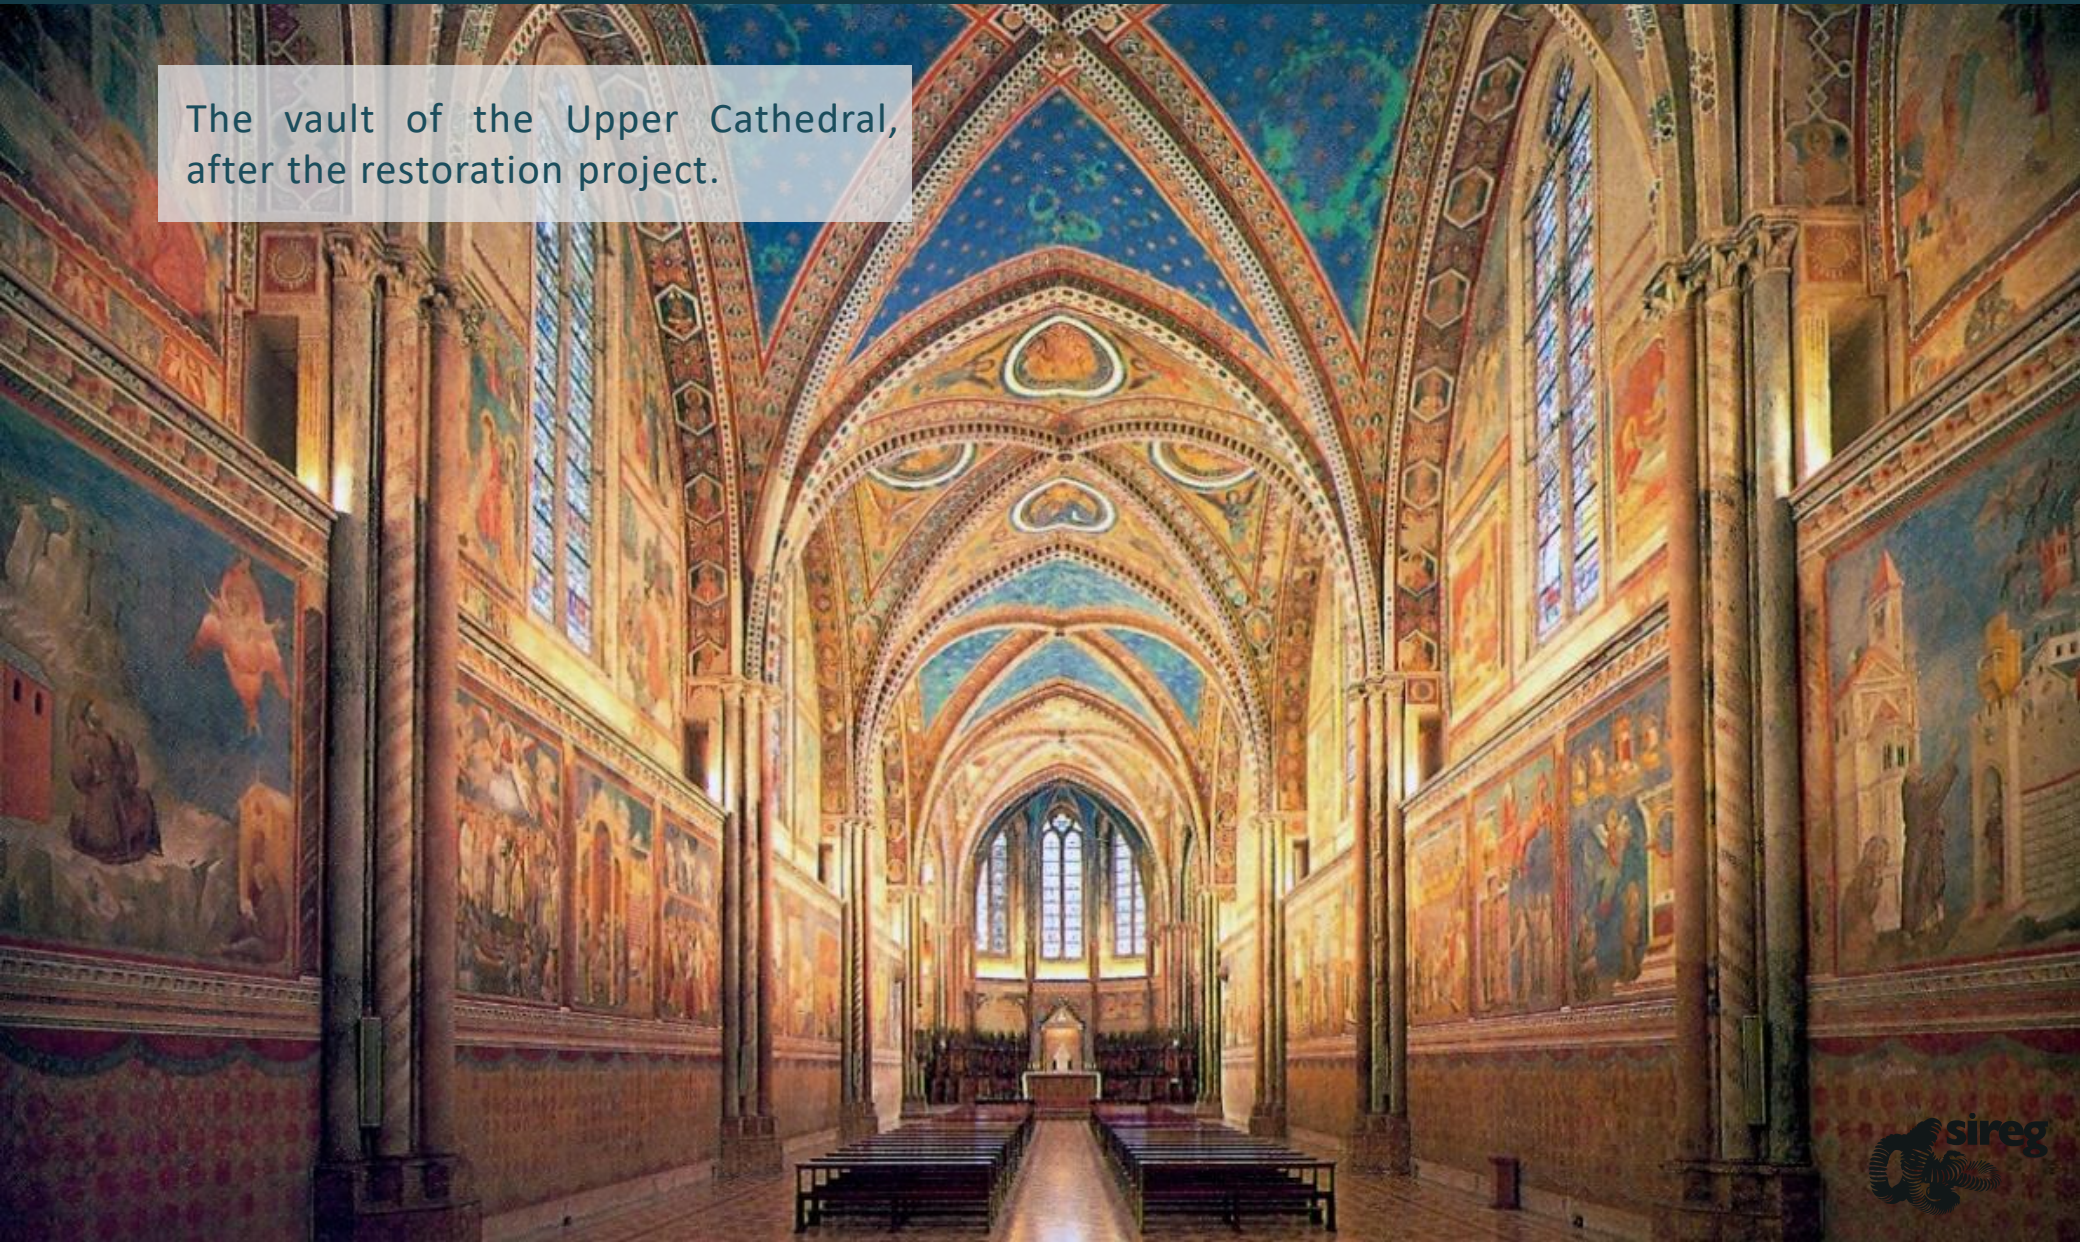
The vault of the Upper Cathedral, after the restoration project.
